Executive Summary/Planning Guidelines

Long Range Facility Audit 2009-2019

Clovis Unified School District • August 2009

Clovis Adult School

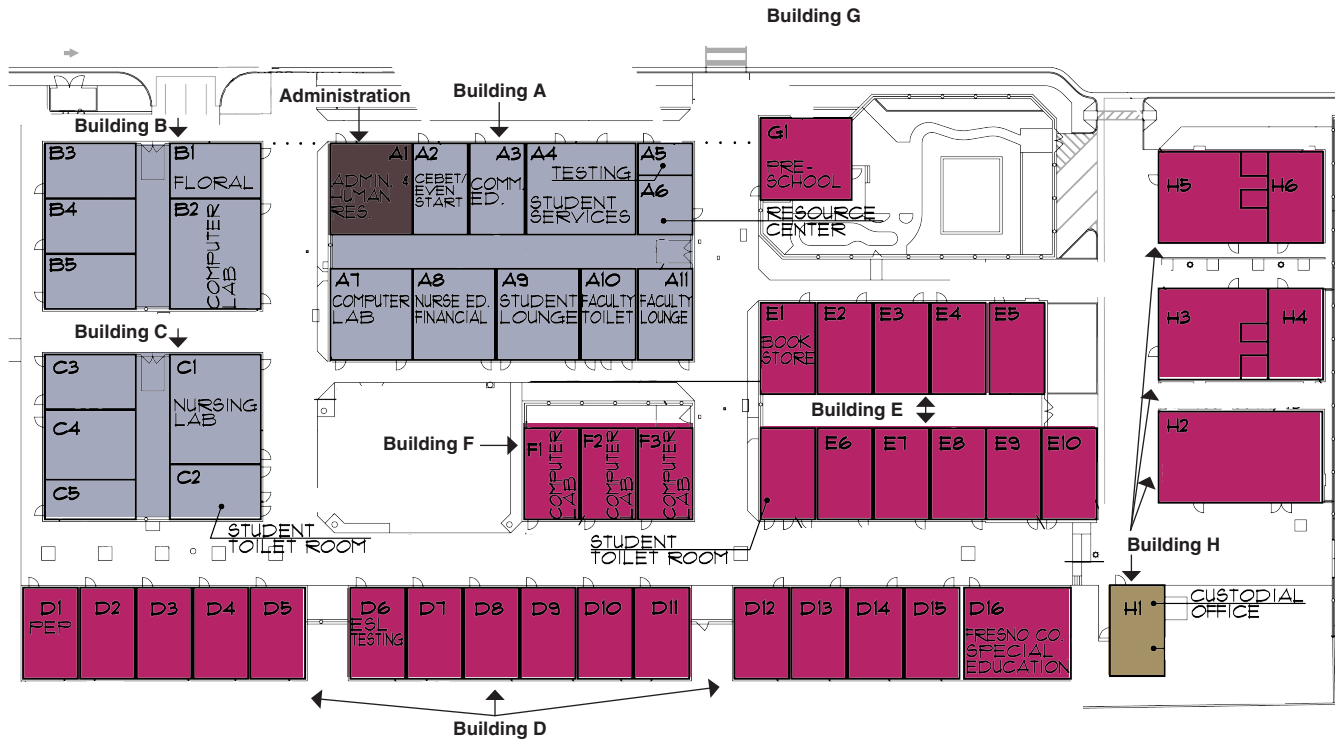
Site Plan

Observation: The concrete and asphalt concrete condition is good. The accessible stall signage and striping require minor changes. Some of the accessible stalls do not have an ADA compliant path of travel. ADA detectable warning surface is required in multiple locations.

Observation: The irrigation system is 15 years old and is in good working condition. Minor irrigation repairs are required in various planter areas.

Observation: The overall Fire Alarm system is in poor condition and is not compliant with current electrical codes and District standards. Approximately 75% of devices and wiring are in poor condition. The control panel is fairly new and in good condition but the door does not close properly.

Observation: The Clovis Adult School public address system is in good condition but does not completely meet district standards. Loudspeaker coverage is inadequate in some external areas. Public address cabling is not compliant with current industry standards and electrical codes.

Recommendation: Add concrete improvements to meet ADA compliant path of travel requirements. • Add accessible stall signage and striping as required. • Add ADA detectable warning surface at multiple locations.

Recommendation: Repair irrigation in various planter areas as required.

Recommendation: Replace about 75% of devices and wiring. • Replace control panel enclosure.

Recommendation: Replace site system cabling. • Install additional loudspeakers for external coverage.
