Long Range Facility Audit 2009-2019

Clovis Unified School District • August 2009

Mickey Cox Elementary School

HMC
Architects

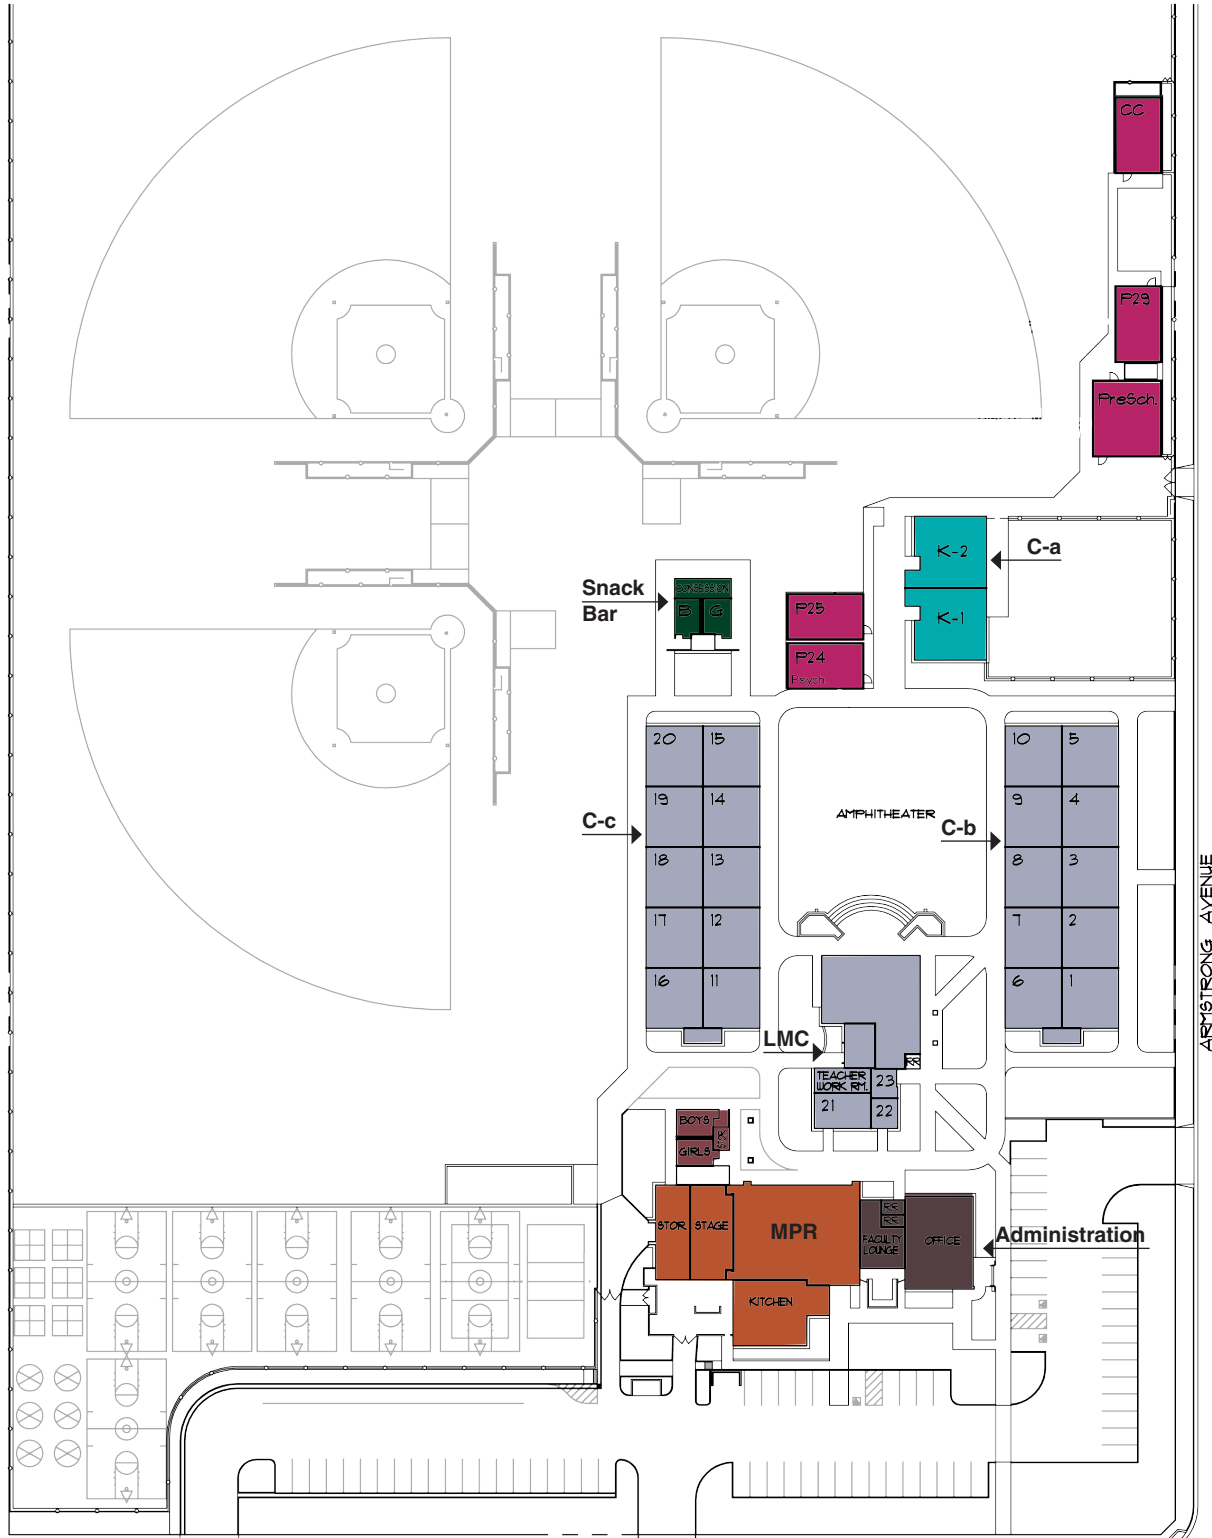
Site Plan

Observations: The concrete condition is good. There were locations of minor cracking and trip hazards. The ramps and curb ramps do not meet ADA requirements. The accessible stall signage and striping require minor changes. ADA detectable warning surface is required in various locations. Storm drain inlet grates do not meet ADA requirements for maximum grate openings. Walk gates do not meet ADA requirements. Some of the drinking fountains do not meet ADA requirements.

Observations: The storm drain system is in good working condition, but there are minor issues of standing water.

Observations: There are a few locations of bare planters. There are a few locations of bare turf. Weed control is fair. There are 5 hazardous trees in the parking area. There is a concrete amphitheatre on campus.

Observations: The irrigation system is 6 years old and is in good working condition. Minor irrigation repairs are required in various planter areas.

Recommendations: Reconstruct concrete improvements to eliminate trip hazards and meet ADA slope requirements.

- Add accessible stall signage and striping as required.
- Add ADA detectable warning surface at various locations.
- Replace storm drain inlet grates in accessible paths of travel with ADA compliant grates.
- Replace walk gates with ADA compliant gate hardware.
- Replace drinking fountains with ADA compliant drinking fountains.

Recommendations: Add additional storm drain inlets to prevent standing water.

Recommendations: Add shrubs, ground cover, and trees to bare planters. • Replace turf in bare areas. • Eradicate weeds as required. • Remove hazardous trees.

Recommendations: Repair irrigation in various planter areas as required.
