Executive Summary/Planning Guidelines

Long Range Facility Audit 2009-2019

Clovis Unified School District • August 2009

Clovis Adult School

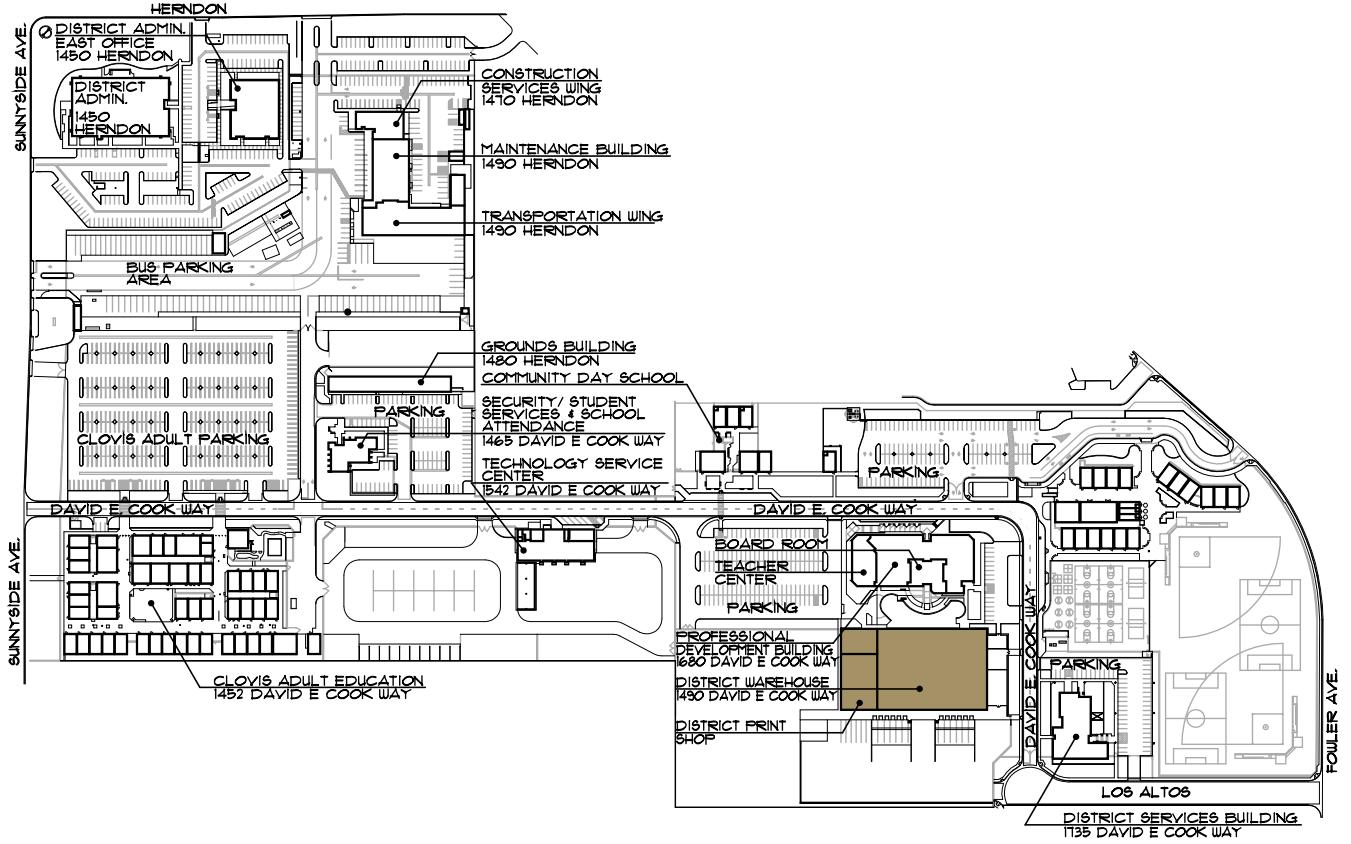
Site Plan

Observation: The concrete condition is good. ADA gates are required for sidewalk access. ADA detectable warning surface is required at curb ramps.

Recommendation: Add ADA gates. • Add ADA detectable warning surface at curb ramps.
