Long Range Facility Audit 2009-2019

Clovis Unified School District • August 2009

Maple Creek Elementary School

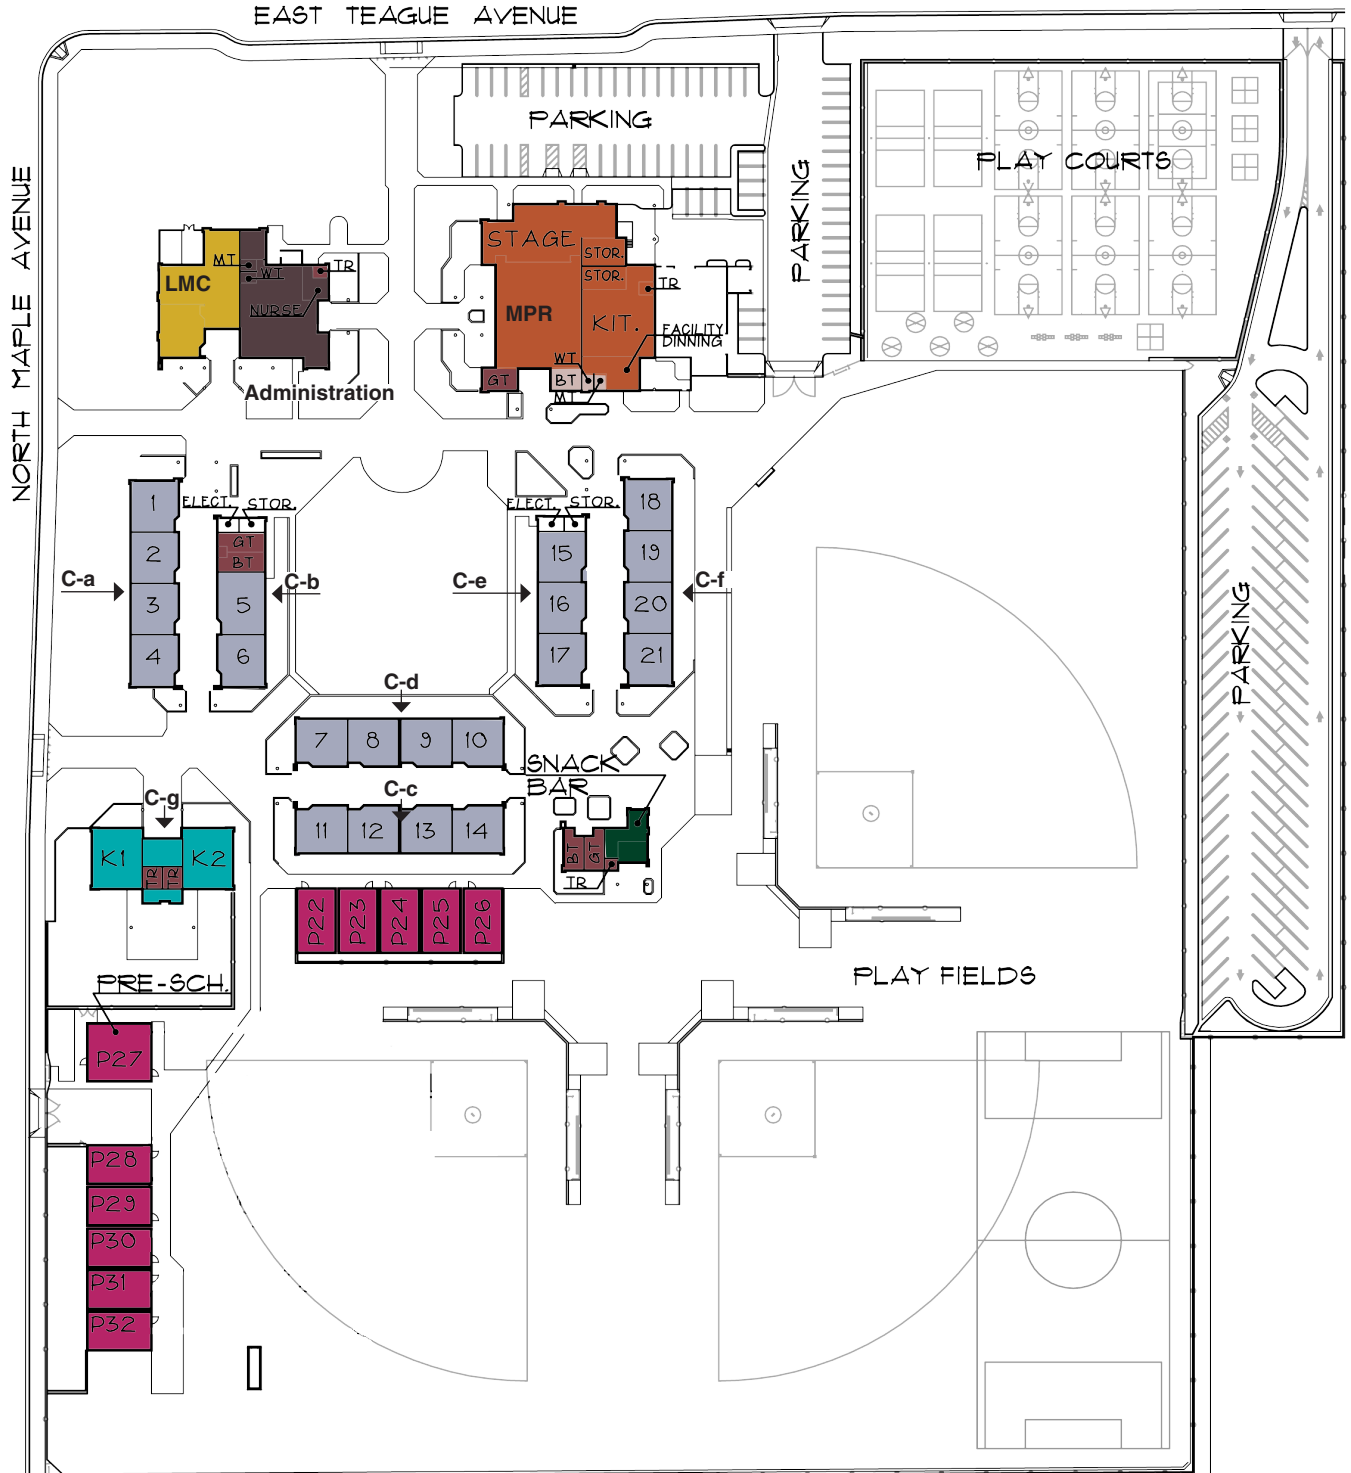
Site Plan

Observations: The concrete condition is good. There are locations of minor cracking and trip hazards. In some areas, sidewalk cross-slope does not meet ADA requirements. The curb ramps do not meet ADA requirements. The accessible stall signage and striping require minor changes. ADA detectable warning surface is required in various locations. Storm drain inlet grates do not meet ADA requirements for maximum grate openings. Walk gates do not meet ADA requirements.

Observations: The storm drain system is in good working condition, but there is evidence of standing water behind the portables.

Recommendations: Reconstruct concrete improvements to eliminate trip hazards, comply with ADA curb ramp requirements and cross-slope issues. • Add accessible stall signage and striping as required. • Add ADA detectable warning surface at various locations. • Replace storm drain inlet grates in accessible paths of travel with ADA compliant grates. • Replace walk gates with ADA compliant gate hardware.

Recommendations: Add additional storm drain inlets to prevent standing water.
